BUILDING 2054

CONDITION SURVEY DATA SHEET

CONDITION SURVEY

SHOP

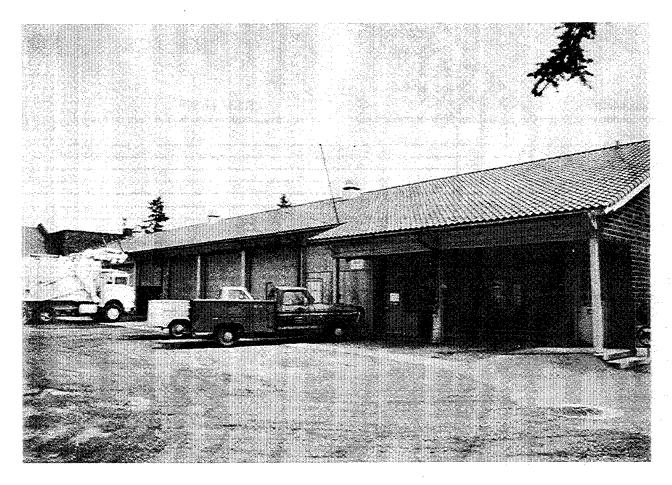
1987 PHOTO

- 1. Masonry is soiled.
- 2. Gutter is torn over porch.
- 3. Rust is present at steel sashes and at lintels.
- 4. Moss is present on chimneys.
- 5. Mortar is missing from chimney at corner.

- 6. Scupper boxes at east are not tied to downspouts.
- 7. Mortar is missing from parapets at corner. Masonry is mossy and soiled.
- 8. Mortar has washed away from joints where scupper boxes dump onto building face. Masonry is weakened and soiled.

- 9. Vehicle damage to north face.
- 10. Paint is loose at eaves.
- 11. Truss ends at north side are rusting.
- 12. Glazing is painted some locations.
- 13. Moss is present in gutters.

- 14. Fascia is soiled behind gutter.
- 15. Window glass broken, north end.
- 16. Broken masonry has been stuffed with rags.
- 17. Gable end and eave is soiled.

- 18. Vehicles have damaged some downspouts.
- 19. Two downspouts are not connected to boots.
- 20. Original doors are weathered and defaced by signage.
- 21. Steel jambs and corners are rusting.
